**REPORT OF THE INFANTRY BOARD #1628, MODIFICATION OF TRIGGER SPRING,
CARBINE, CALIBER .30, M1 FORT BENNING, GEORGIA 10 JUNE 1944**

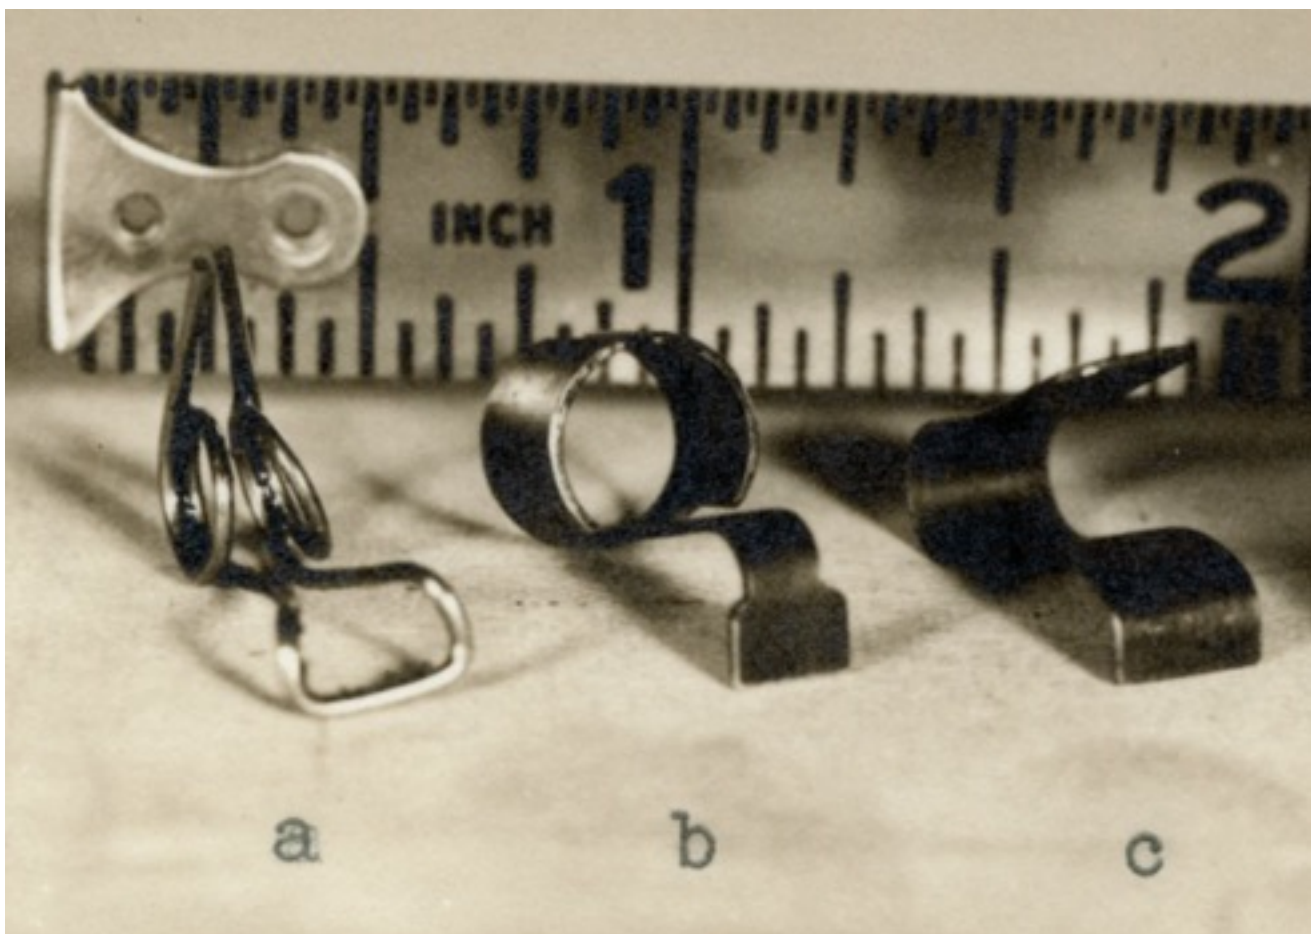
a. Standard Carbine Trigger Spring. b. Cavalry School Trigger Spring c. Ordnance Trigger Spring

1. The subject trigger springs do not appreciably affect the trigger pull on the M1 Carbine and the M1 Carbine (Modified).
2. Neither of the subject springs is as rugged as the present standard spring.

3. None of the Cavalry type (Sgt. Brooks) trigger springs lasted through the abusive test. Four broke on the M1 Carbine after an average of 5800 trigger actuations, per spring, and four broke on the M1 Carbine (Modified) after an average of 3300 trigger actuations per spring.

4. One of the Ordnance springs lasted 44,031 actuations and the other 50,000 (only two were received for test).
5. The present standard springs operated efficiently during the test.

Recommendation: The Infantry Board recommends that the two types of subject springs be considered as unsatisfactory for purpose designed, and that no further consideration be given to their development."
